PORCH WALL REPAIRS.
ST. BARTHOLOMEW'S CHURCH,
WIGGINTON, TRING, HERTS.
HP23 HPZ

FRONT AND SIDE ELEVATIONS
 Title **INDICATIVE NOT TO SCALE.**

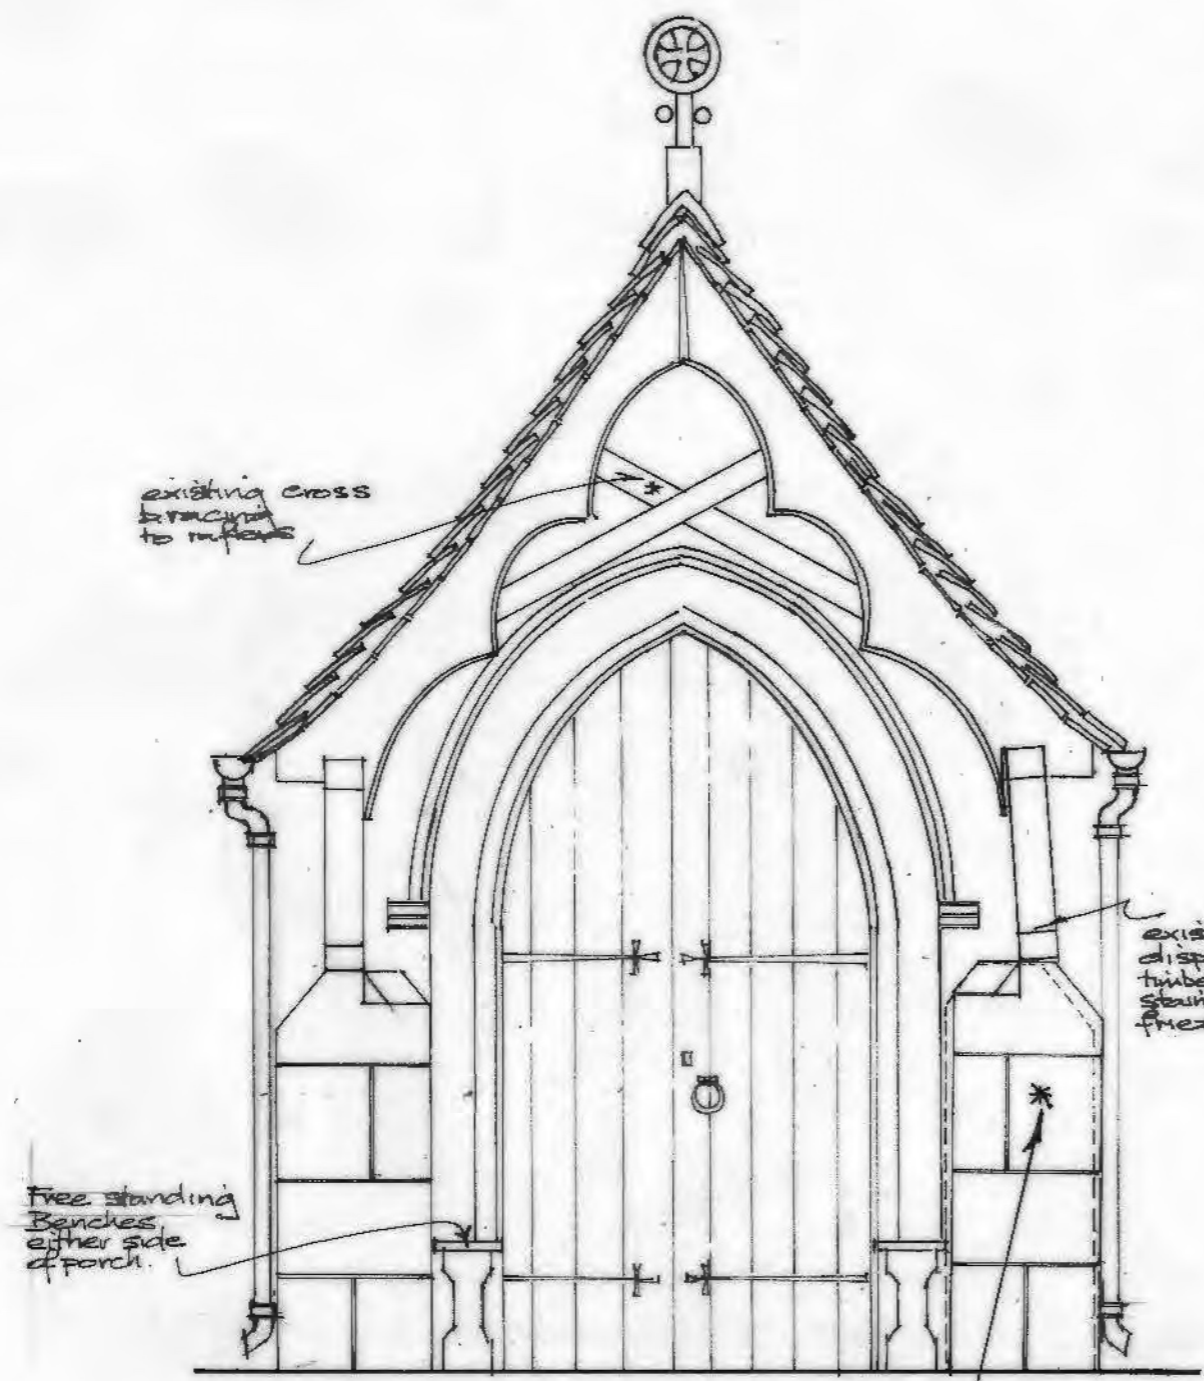
FRONT ELEVATION

THE WALL SUBJECT OF THE REPAIR WORK

Cast iron downpipe with discharge over gully see Drawing No 2261/5/A3:1
